**Docket No. 217 – Development and Management Plan Inspection**

Northeast Utilities Service Company Certificate of Environmental Compatibility and Public Need for the construction of a 345-kV electric transmission line and reconstruction of an existing 115-kV electric transmission line between Connecticut Light and Power Company's Plumtree Substation in Bethel, through the towns of Redding, Weston, and Wilton, and to the Norwalk Substation in Norwalk, Connecticut.

**Date:** June 28, 2005

**Location:** 345kV XLPE Component

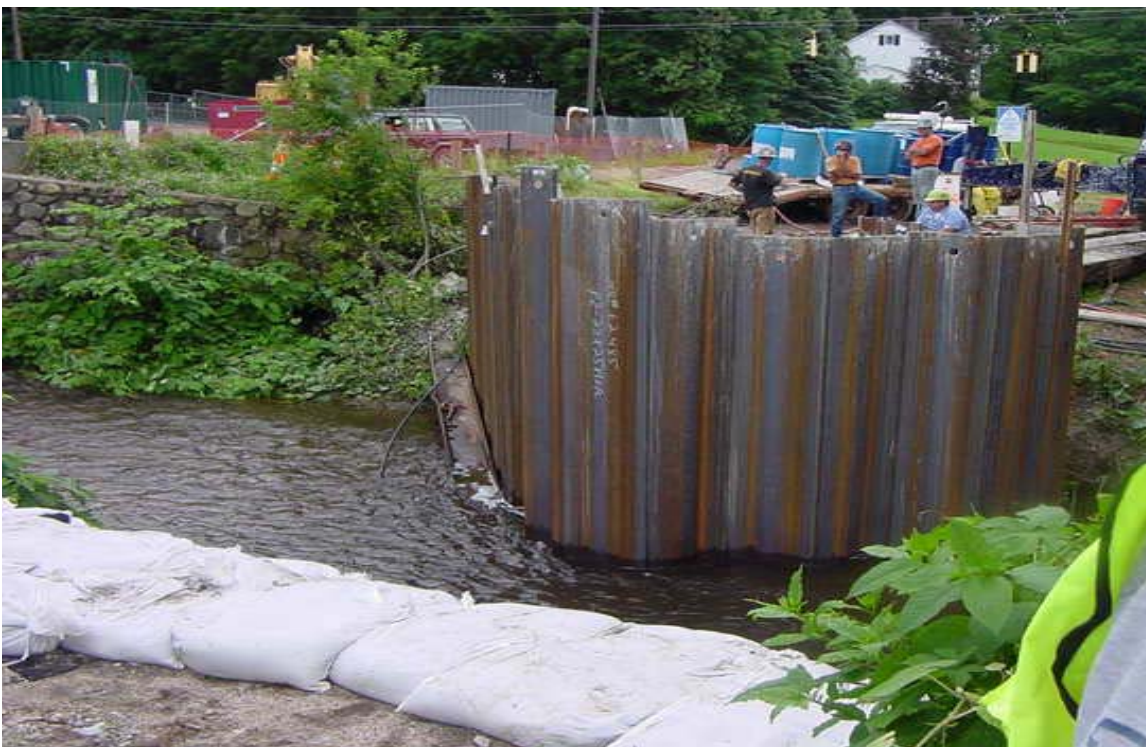
345kV XLPE: Photo shows the sheet piling in place across half of the stream in an attempt to divert the water above the bore. The stream remains in good condition at this time. 6/28/06

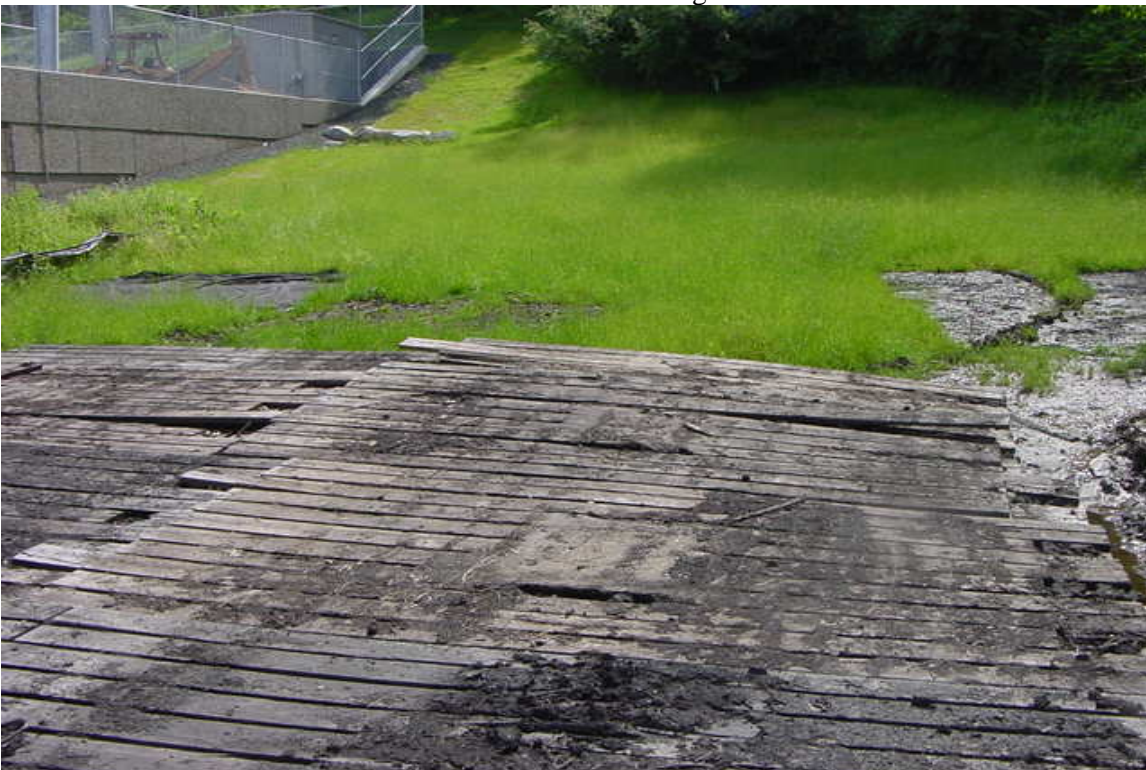
Photo shows the mats in the wetland area off Rt 58 for machinery access to pull wire in another section of the project. Once access is complete, 345kV XLPE crews will be restoring this area. The remainder of the slope is very well vegetated. 6/28/06
